Form 504 Ed. June, 1928 DEPARTMENT OF COMMERCE	PAGES 15 AND 17		
U.S. COAST AND GEODETIC SURVEY	COAST & FEDERAL SHEET SH		
	Jan 377 assi		
DESCRIPTIVE REPORT	P. P. C.		
Topographic Sheet No. 5056 Hydrographic Project *48 LOCALITY			
West Coast			
Seminole Pt. to Lopez River			
1930_			
CHIEF OF PARTY			
B.H. Rigg

State Florida
General locality West Coast
Locality Chatam River Seminole Pt. to Lopez River
Scale 1:20,000 Date of survey Jan-Feb , 1930
Vessel Chartered Houseboat 'MYJO"
Chief of Party Benjamin H. Rigg
Surveyed by Benjamin H. Rigg
Protracted byFred Natella
Soundings penciled by G.E. Morris
Soundings in fathoms feet
Plane of reference M.L.W.
Subdivision of wire dragged areas by
Inked by
Verified by
Instructions dated
Remarks: Boat sheet & Smooth sheet for this work Was furnished
by the Washington, Office. (T-4452 Aerial)

SECTION OF FIELD RECORDS REPORT ON SHEET H-5056 SEMINOLE PT. TO LOPEZ RIVER, FLA.

Review of Hydrographic Sheet No. 5056

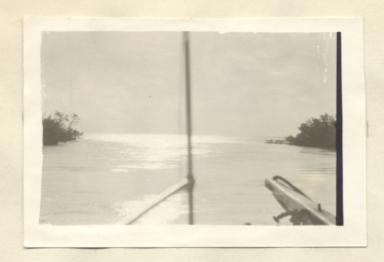
CHATAM RIVER ENTR . LOOKING WEST

Entrance to Chatham River passes over a wide bar with three feet at low water. Once over the bar three and one half feet can be carried into the river. Numerous bars and shoals make a pilot necessary to run the river with a yacht. Yachts never go any further than the entrance to Chevelier Bay, two feet may be carried this far. The shoalest spot in Chatham River lies in Lat. 25°48.1 Long. 81°16.6. In this locality, the channel as found by the party is only 2 feet deep and very narrow; the deepest water lies close to the island lying on the north side.

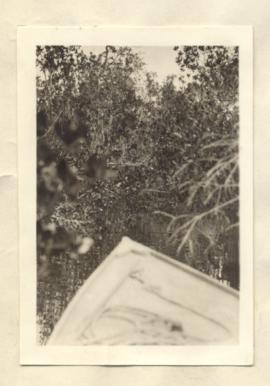
PLATE GREEK ENTRANCE

Alligator Bay has a general depth of from 3 to 5 feet. An attempt was made to run a line into the entrance of Plate Creek at the southeast end of the bay but it was found to be completely blocked. Two feet was as near as we could estimate the soundings, due to a layer of very soft mud, three to four feet deep. A photo included in this report shows the entrance.

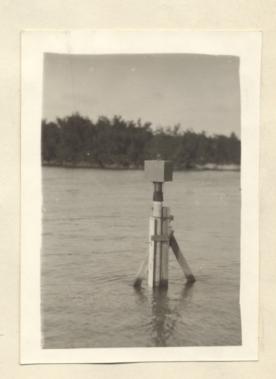
TIDE GUAGE CHATAM RIVER

A portable tide gauge was installed at the mouth of Chatham Bend River and a staff was erected near the mouth of Chevelier Bay. Comparisons were made with the standard gauge at Everglades. From the automatic gauge and the staff at Chatham River, reducers were obtained for all this sheet. The tide staff readings were used for Lopez River, Sunday, Oyster, Heuston, Chevelier, Cannon and Alligator Bays.
